Monitoring Data Record

Project Title: R-2210A Site 1 (Waynesville Site 1) COE Action ID: 200130653  
 Stream Name: Raccoon Creek DWQ Number: 010409  
 City, County and other Location Information: Sta. 30 on Bus. 23 S in Waynesville, Haywood Co.  
 Date Construction Completed: July 2003 (lower portion) Monitoring Year: ( 2 ) of 5  
 Ecoregion: \_\_\_\_\_ 8 digit HUC unit 06010106  
 USGS Quad Name and Coordinates: \_\_\_\_\_

# Waynesville Site 1

Year 2 – May 2005

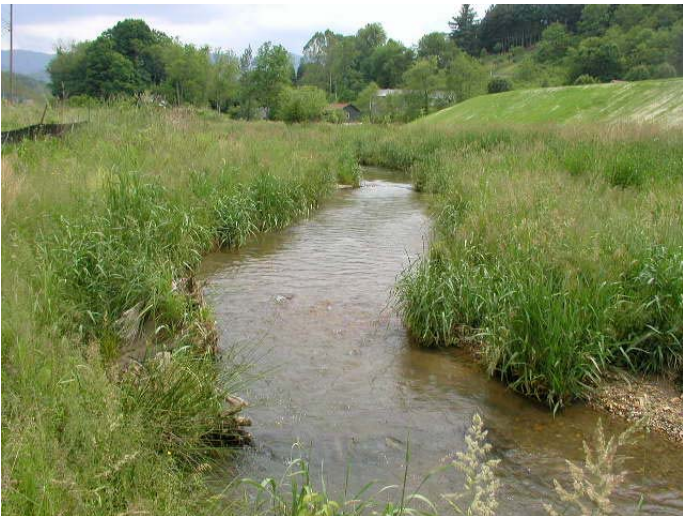
Photo 5

The stream is stable and is doing well. Water is cutting behind a rootwad, which is noted in photo 5. The streambank is stabilized at this area by vegetation and is not a problem at this time.

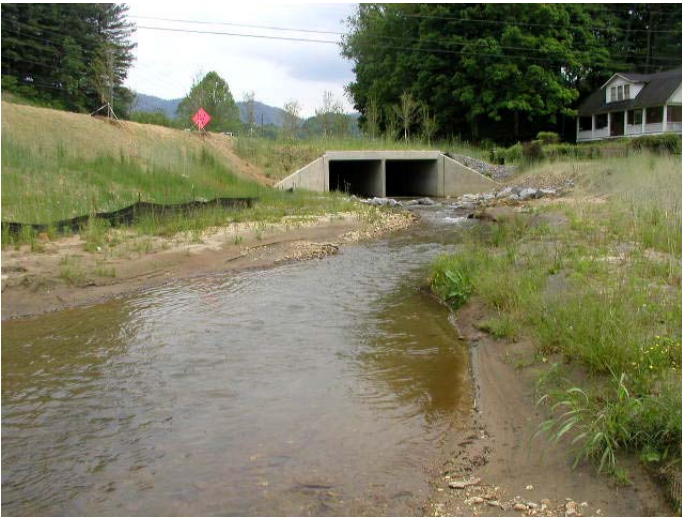
Photo 9

The upper portion of the stream is still under construction and needs some additional plantings to take place.

Permanent photo stations (photos 9, 10, 11, and 12) were installed on the upper portion of the stream and recorded this monitoring period.

Estimated causes, and proposed/required remedial action: The upper portion of the stream will be planted in 2006.
